FP52I06 FLOOR PAN TECH BULLETIN

REVISION 1: 8/16/2006

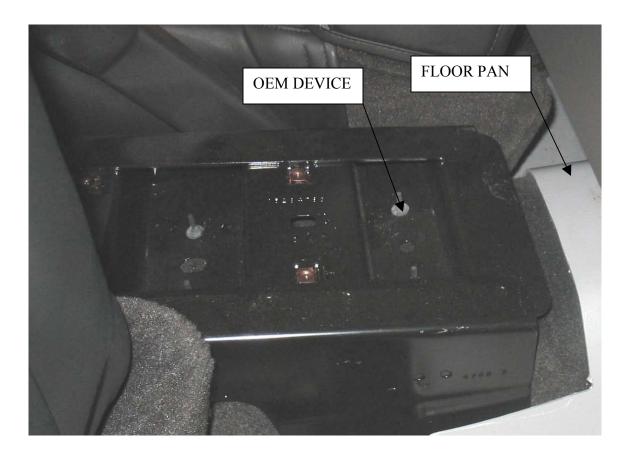
Note: The manufactory's protective device located between the front seats should not be altered. As a result of this, and the different aftermarket console lengths, the Pro-gard floor pan (FP52I06) will have to be altered. See the following photo for reference only.
